D-622  
Baker House  
East New Market  
private

# Maryland Historical Trust State Historic Sites Inventory Form

Survey No. D-622

and/or common BAKER HOUSE

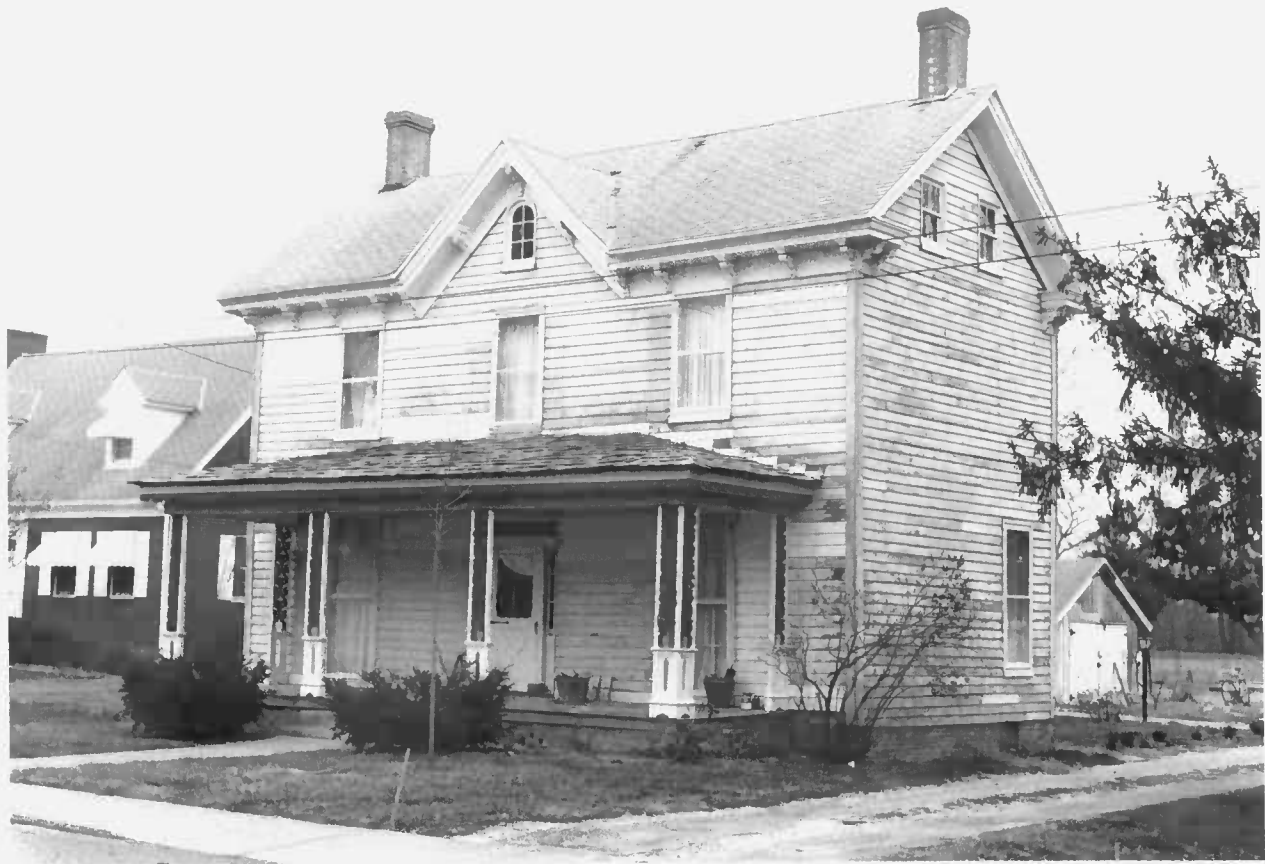
Southwest elevation

The west (main) facade is a symmetrical three-bay elevation with a center entrance and flanking six-over-six sash windows. The mid nineteenth-century four-panel door is framed by three-pane sidelights and a four-pane transom. Louvered shutters flank the adjacent windows. Stretching across the entire front of the first floor is a hip roof porch distinguished by elaborate sawn support posts with exuberant sawn corner brackets and fascia trim. The second floor is lighted by three evenly spaced six-over-six sash windows and the center cross-gable is pierced by a round arched two-over-two light. Embellishing the perimeter of the roof are decorative brackets.
